Re: Riverbank Soil Sampling Results — Operable Unit 3
Swan Island Upland Facility
Portland, Oregon
ECSI No. 271
1115-08

Riverbank Soil Sampling Results
Swan Island Upland Facility, Operable Unit 3
Portland, Oregon

Attachment A PHOTOGRAPH LOG

Project Name: Swan Island Upland Facility, OU3
Project Number: 1115-08

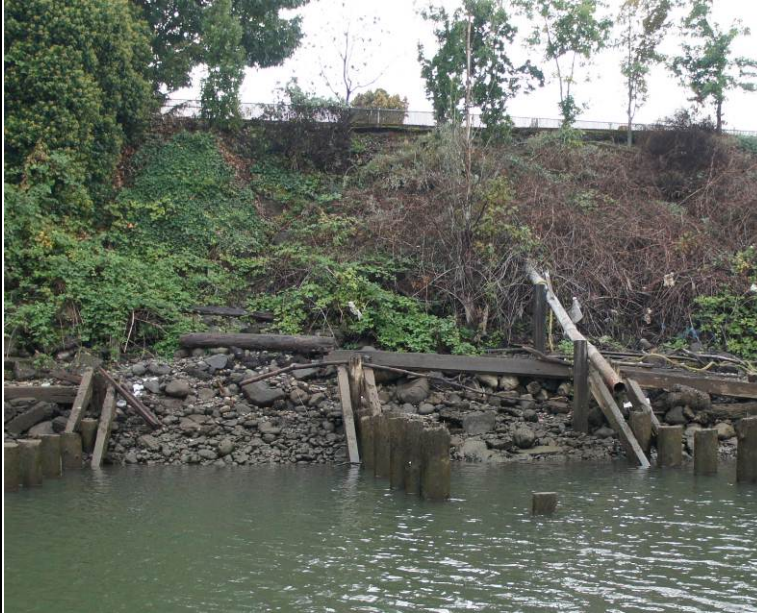
Photo No: 1

Photo Date: 10/10/2011	
Orientation: Southwest	
Description: <u>Feature A</u> Over-steepened cut in river bank, at southeast corner of riverbank (left of the storm water outfall).	
Photo No: 2

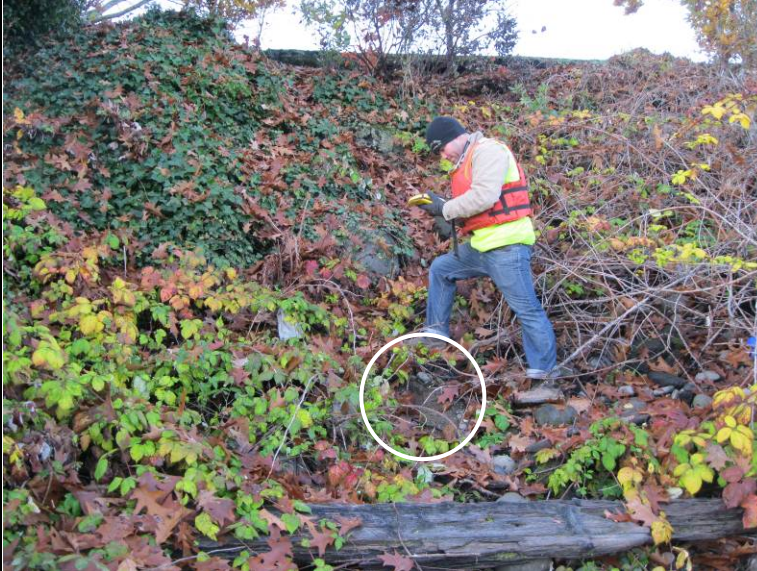
Photo Date: 11/30/2011	
Orientation: Southwest	
Description: <u>Feature A</u> Sample location OU3-RB-1 (in white circle).

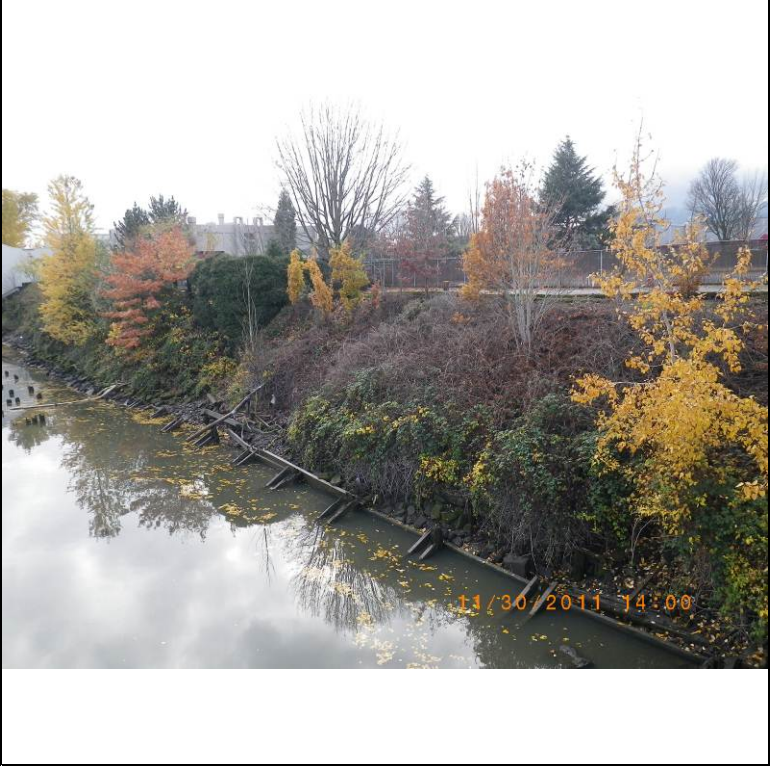
Photo No: 3

Photo Date: 11/30/2011	
Orientation: Southeast	
Description: <u>Feature B</u> Over-steepened slope as seen from Berth 308.	
Photo No: 4

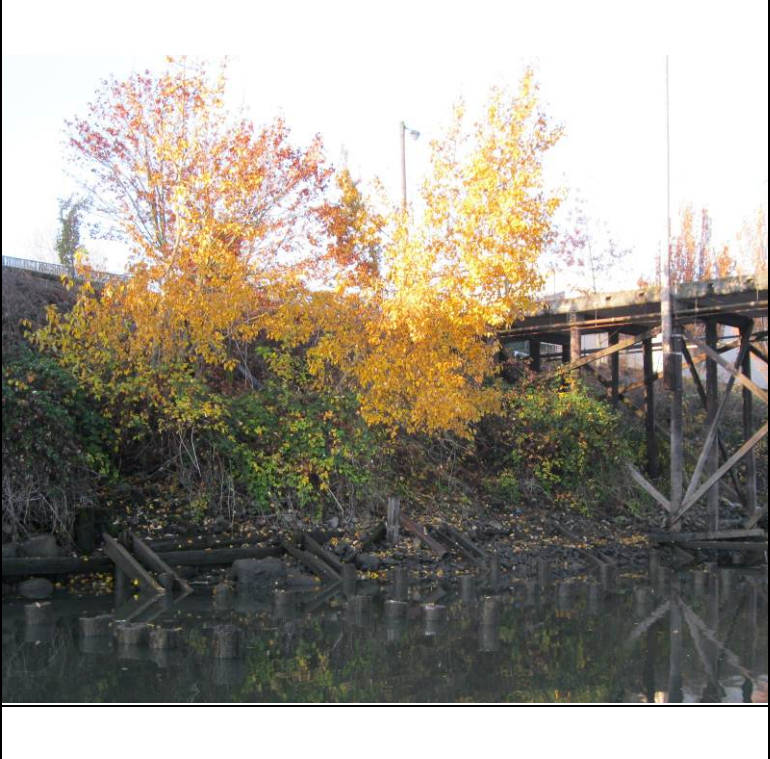
Photo Date: 11/30/2011	
Orientation: Southwest	
Description: <u>Feature D</u> Exposed soil under drip line of Maple tree on riverbank, covered by leaf litter.

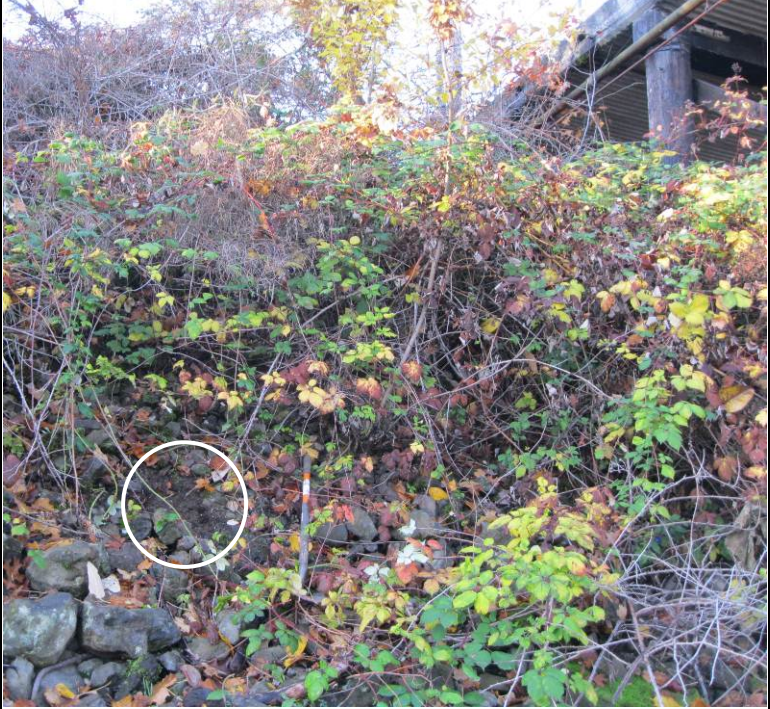
Photo No: 5

Photo Date: 11/30/2011	
Orientation: Southwest	
Description: <u>Feature D</u> Sample location OU3-RB-2 (in white circle). Exposed soil at this location is the result of thin rip-rap cover.	
Photo No: 6

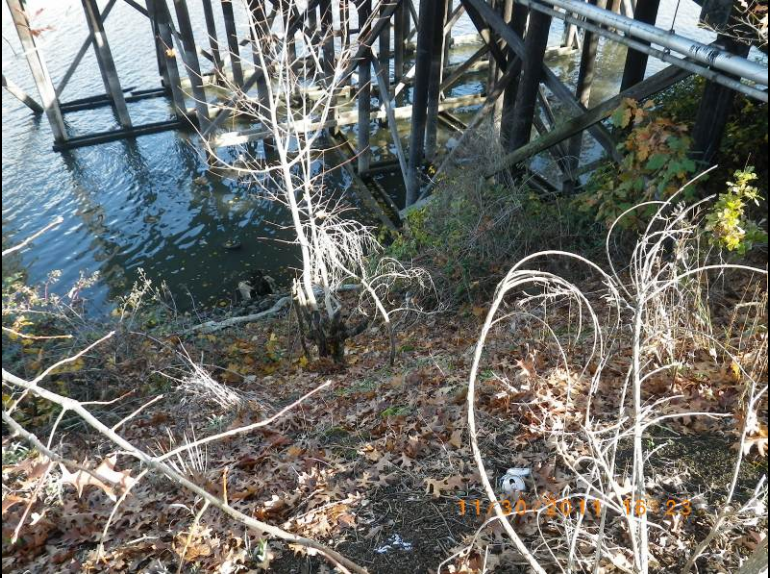
Photo Date: 11/30/2011	
Orientation: Northeast	
Description: <u>Feature E</u> Over-steepened slope with exposed soil west of Berth 308.

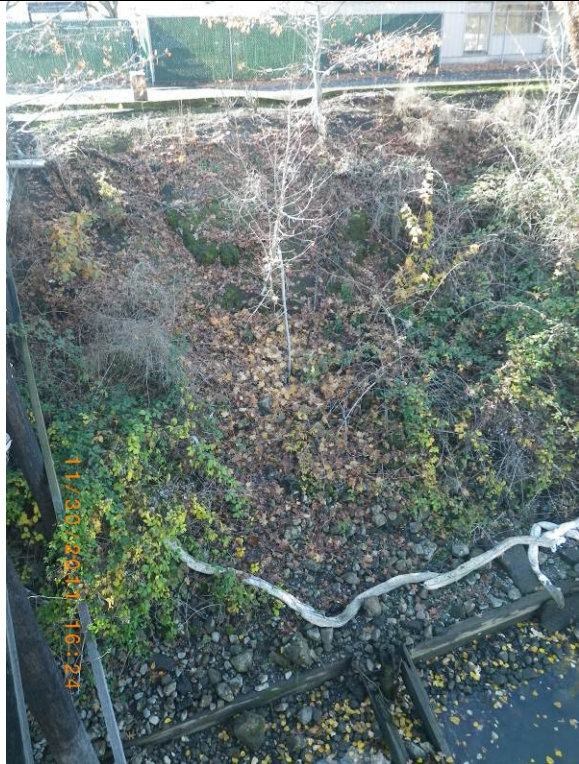
Photo No: 7

Photo Date: 11/30/2011	
Orientation: Southwest	
Description: <u>Feature E</u> Over-steepened slope with exposed soil west of Berth 308.

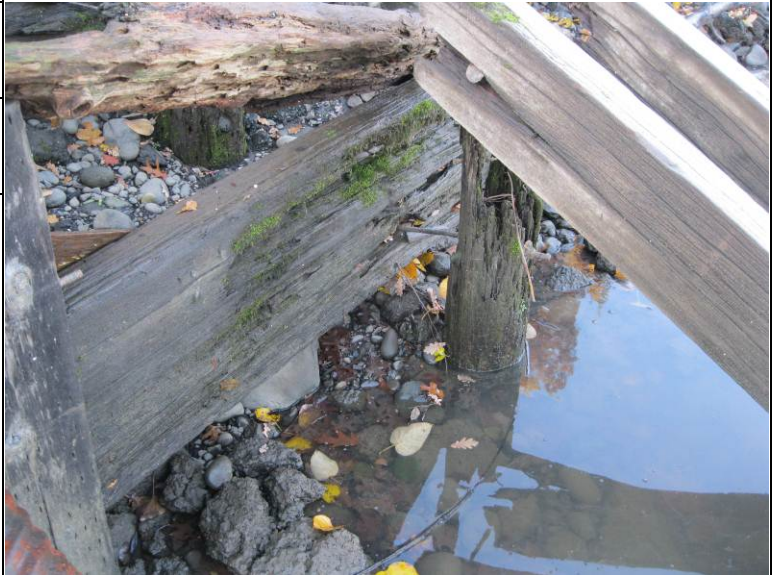
Photo No: 8

- F – Riverbank soil observed sloughing under wooden retaining wall.
- G – Oversteepened slope with exposed soil. No signs of active erosion observed.
- H – Vegetated erosion scarp (maximum height approximately 6 inches). This feature is located near the OLHW with a length of approximately 10 feet.

Photo Date: 12/01/2011	
Orientation: West	
Description: <u>Feature F</u> Rip-rap sloughing under historical wooden wall section.

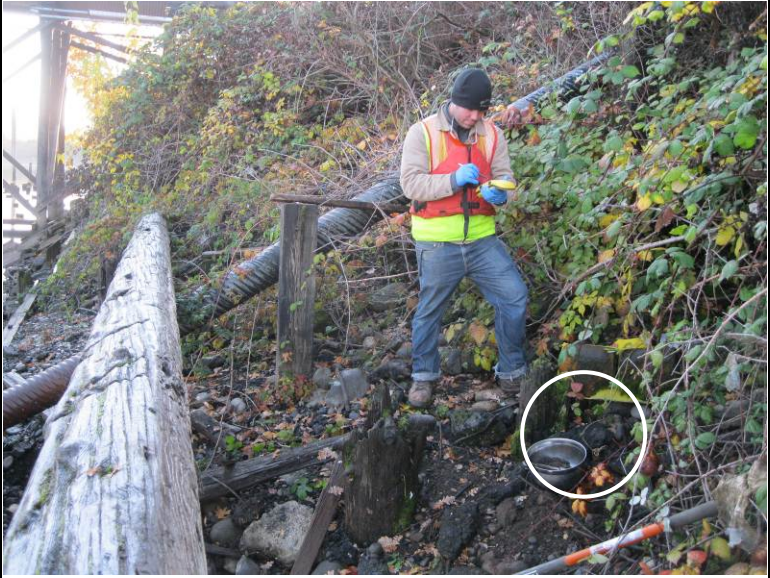
Photo No: 9	
Photo Date: 11/30/2011

Orientation: Southeast	
Description: <u>Feature F</u> Sample location OU3-RB-3 (in white circle).	
Photo No: 10	
Photo Date: 11/30/2011

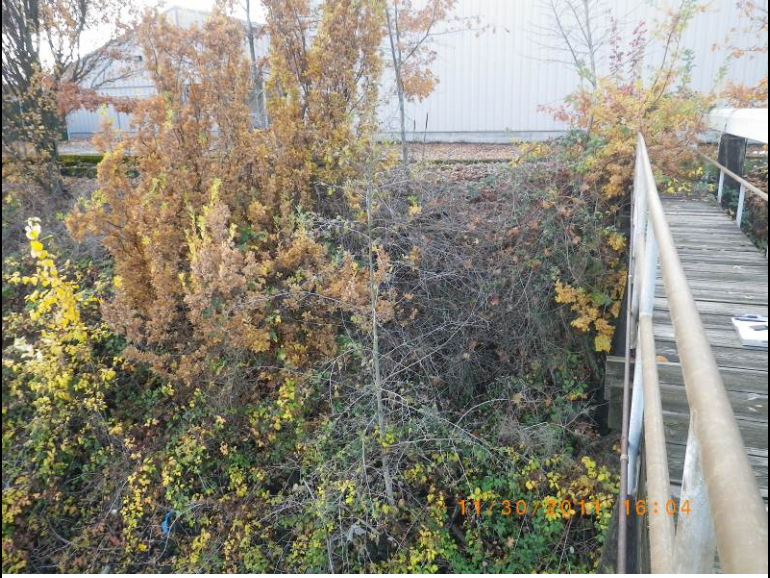
Orientation: Southwest	
Description: <u>Feature G</u> Over-steepened slope with dense vegetation west of manway.

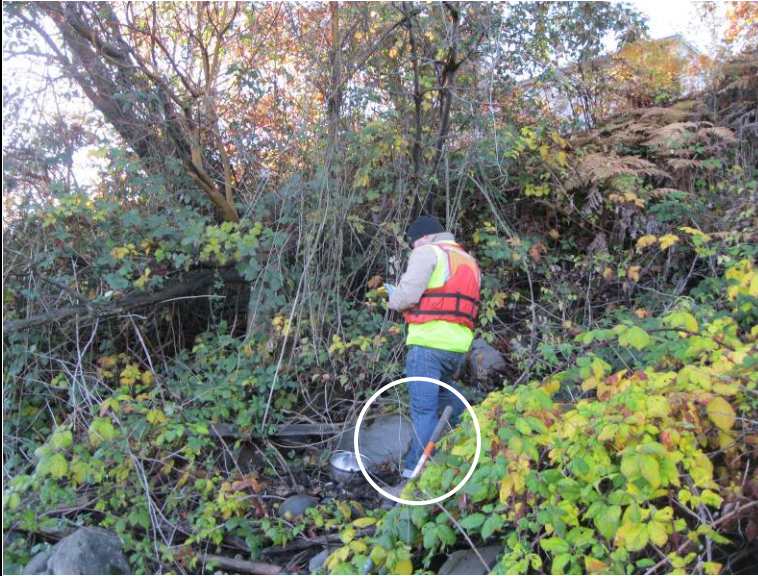
Photo No: 11	
Photo Date: 12/01/2011

Orientation: South	
Description: <u>Feature H</u> Sample location OU3-RB-4 (in white circle).	
Photo No: 12	
Photo Date: 12/01/2011

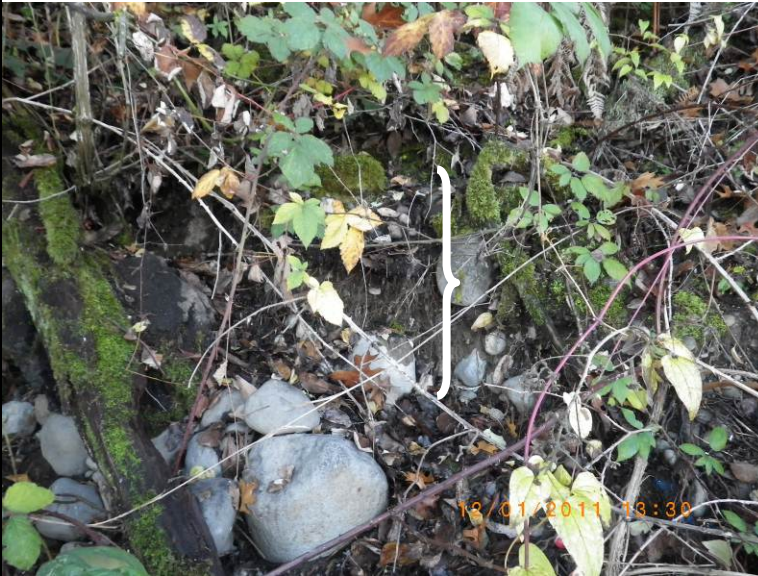
Orientation: Southwest	
Description: <u>Feature H</u> Vegetated erosion scarp with height (approximately 6 inches) emphasized by white bracket.

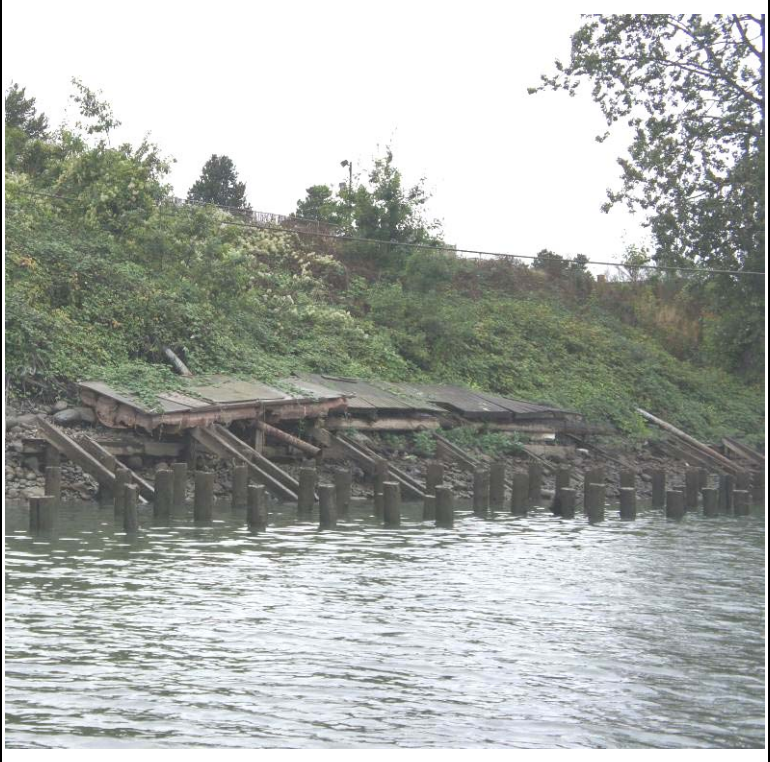
Photo No: 13

Photo Date: 10/10/2011	
Orientation: West	
Description: <u>Feature I</u> Rafted debris near the ordinary line of high water (OLHW).	
Photo No: 14

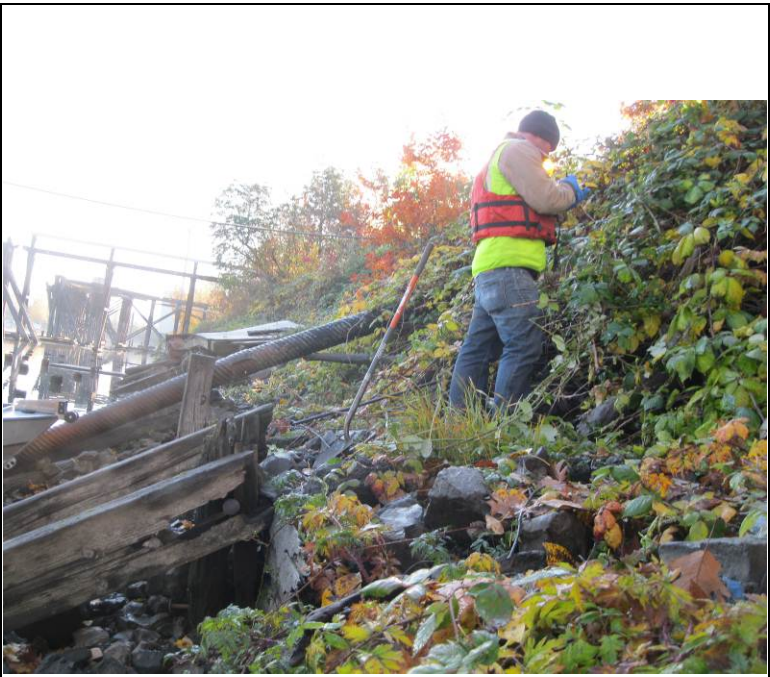
- I – Rafted debris near the OLHW.
- J – Vegetated erosion scarp (maximum height approximately 1 foot). This feature is located near the OLHW with a length of 20 feet.

Photo Date: 12/01/2011	
Orientation: Southeast	
Description: <u>Feature J</u> Vegetated erosion scarp on right of photograph (under thick vegetation). Sample location OU3-RB-5.

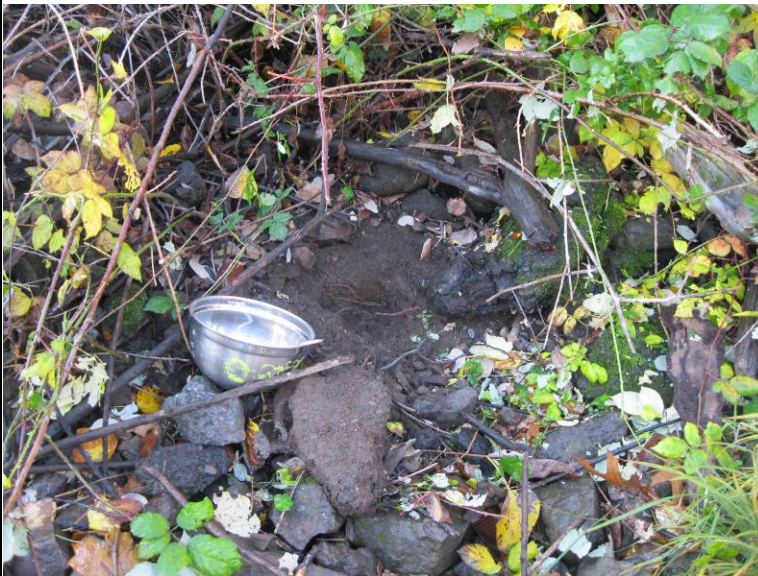
Photo No: 15	
Photo Date: 12/01/2011

Orientation: Southeast	
Description: <u>Feature J</u> Sample location OU3-RB-5 (adjacent to sampling bowl).

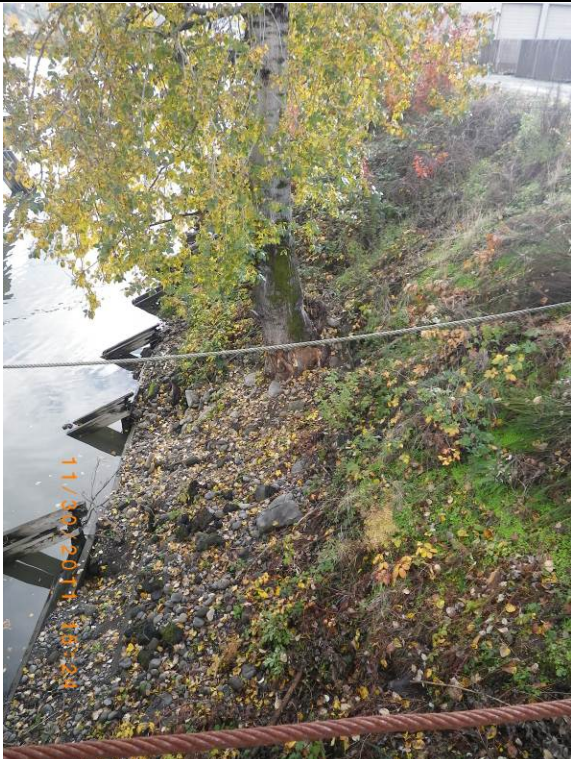
Photo No: 16

- K – Erosion scarp (maximum height approximately 2 feet). This feature is located near the OLHW with a length of 25 feet on OU3 but continues onto OU1.

Photo Date: 11/30/2011	
Orientation: Southeast	
Description: <u>Feature K</u> Erosion scarp at top of rip-rap. The boundary between Operable Unit 3 (OU3) and OU1 is approximated by the rope in the center of the photograph.

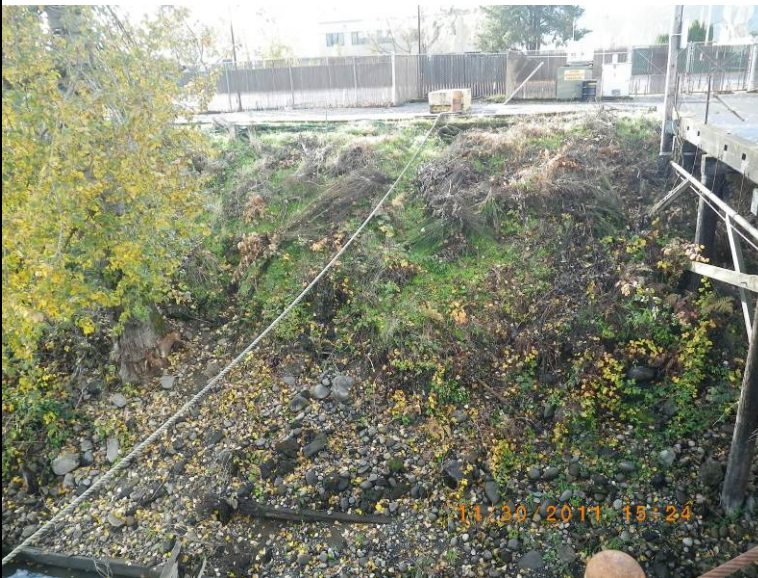
Photo No: 17

Photo Date: 11/30/2011	
Orientation: South	
Description: <u>Feature K</u> Erosion scarp at top of rip-rap. The boundary between OU3 and OU1 is approximated by the rope in the center of the photograph.

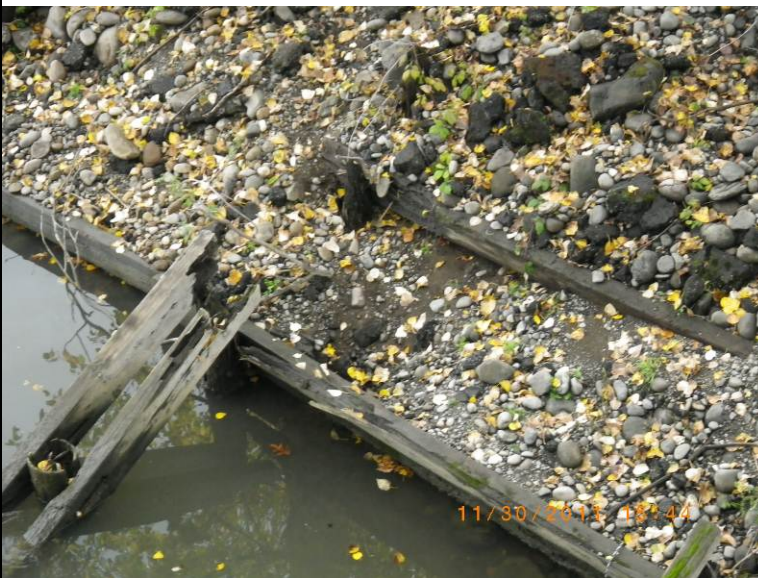
Photo No: 18

- L – Riverbank soil observed sloughing under wooden retaining wall.

Photo Date: 11/30/2011	
Orientation: Southeast	
Description: <u>Feature L</u> Rip-rap sloughing under historical wooden wall section.
